Shotcrete Segment of the O'Hare and Midway Reconstruction Project

2016 OUTSTANDING REPAIR & REHABILITATION PROJECT

Project Name
Structural Bridge Repair at O’Hare International and Midway Airports

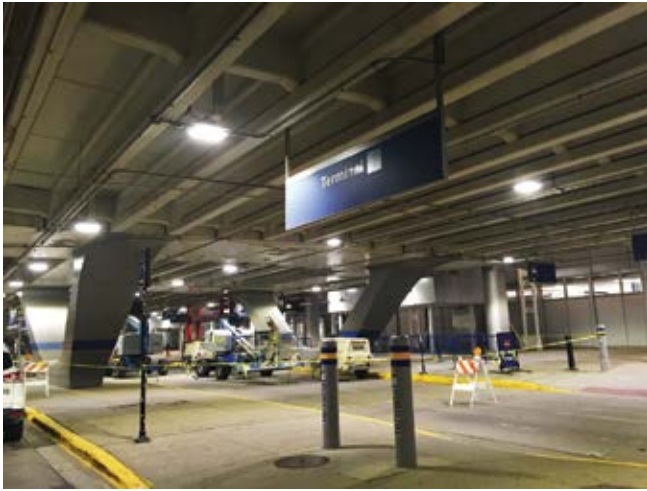
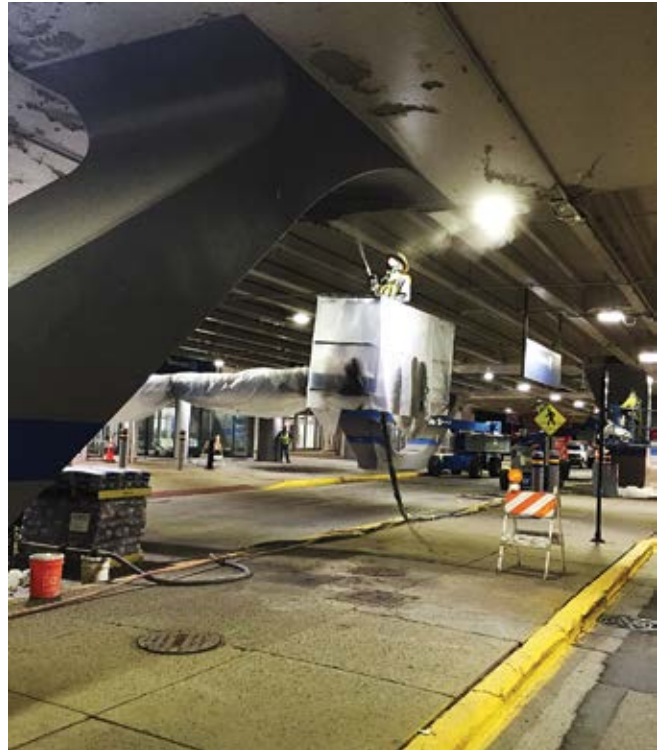
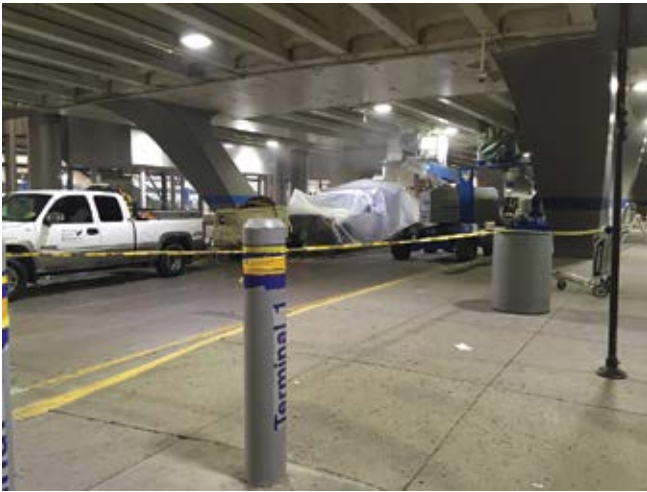
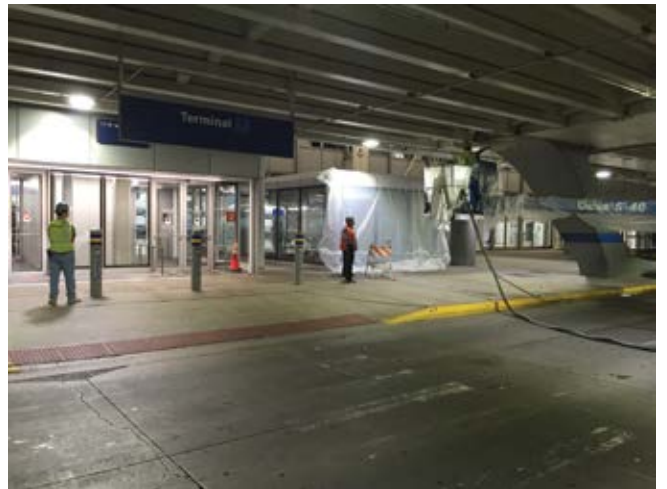
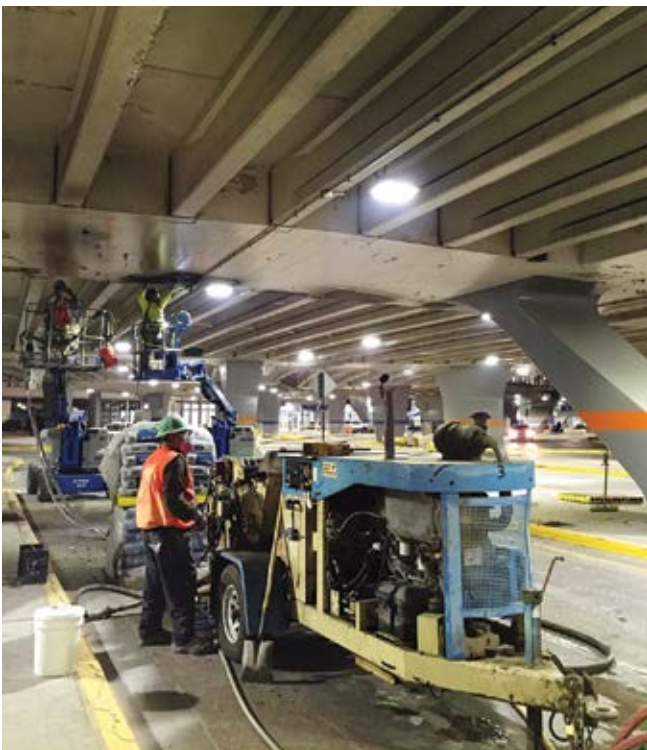
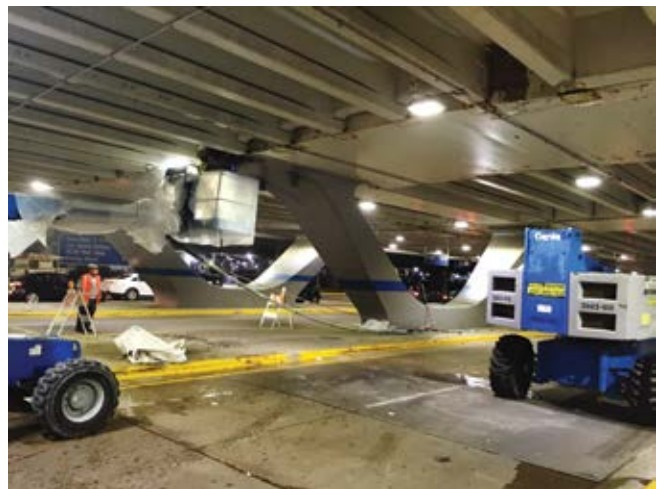
Challenging restrictive work conditions
